## Berkeley Art Museum

For our exploration of an important structural element of the Berkeley Art Museum, we chose one of the steel columns supporting the exterior. In 2000 the university decided that the whole museum needed a seismic retrofit to remain standing while its replacement was under construction. It cost \$4 million and included the construction of **steel columns inside the building, cross-braces in the skylights, and the exterior columns.** These were installed at five points to provide support for the tiered concrete walls of the museum. This was the extent of retrofit work, considering the museum's need for open gallery space and for preserving its historic architecture.

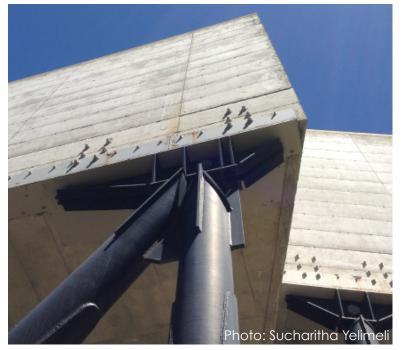
The Berkeley Art Museum is a characteristic example of Brutalist architecture and as such is made of over 100,000 sq. ft. of reinforced concrete. Unfortunately its design is currently "poor" according to modern seismic standards, especially given its location near a major fault line. Its large masses of cantilevered concrete set on freestanding "tree walls" make it visually striking but also highly vulnerable to earthquakes. In 1996 roofers discovered that some concrete had separated from the underlying metal structure, and this prompted further investigation by Forell/Elsessor Engineers. The team identified some of the primary concerns as "lack of a reliable and continuous load path, lack of ductility, and lack of adequate seismic resistance in the direction perpendicular to the tree walls".

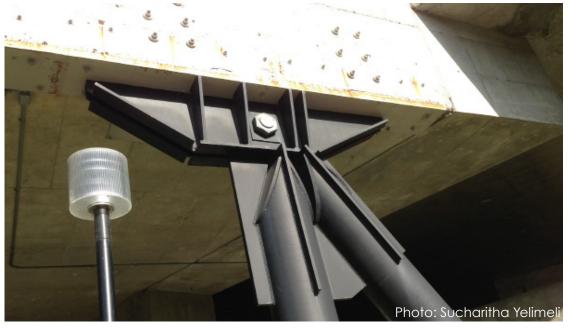
The columns themselves sit on **concrete piers that extend up to 60 feet below the surface** and meet the concrete structure at its projecting edges where it is **most vulnerable**. The individual columns are held together with gusset plates and bolted to steel plates that fold around the lower edges of the concrete galleries. Some are single columns while others, like the one we chose to model, are assembled in groups of two or three. They **distribute the load** of the building deeper points within foundation and are designed to hold up the primary structure if it fails during an earthquake.

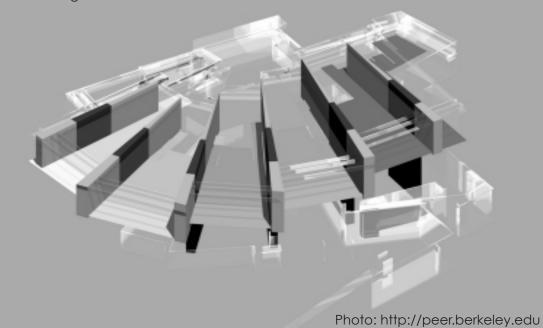
Detail showing floor and wall structure
